The Problem

Two new single family residences had been constructed on a structural fill that had been placed to raise the grade on the lots that backed onto a wooded drainage ravine. The structural fill was placed over the native soil during May/June, 1993. Construction of the foundation for the residences was started in June, 1994 and completed in September, 1994. Cracks in the exterior brick facing of residences were first noticed in November, 1994.

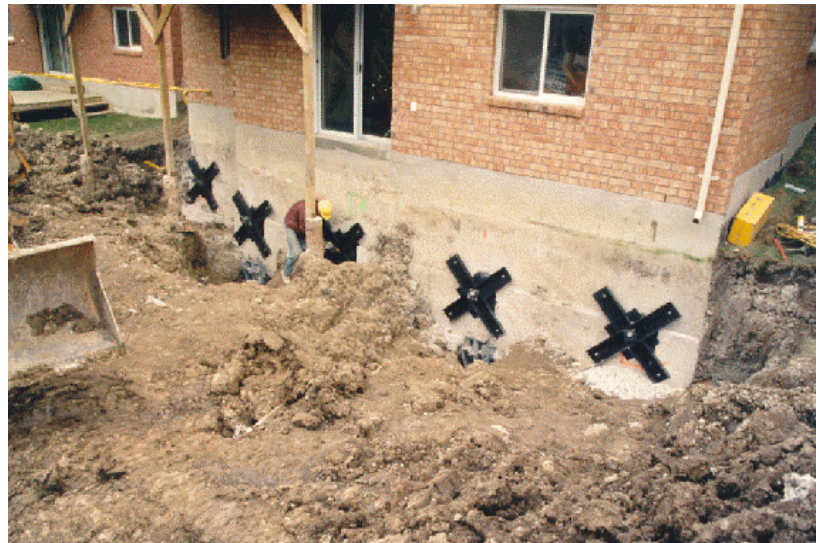
Based on the geometry and history of the cracks, it was apparent that there was some movement occurring, both horizontally and vertically. The amount of fill placed under the building foundations in May/June 1993 appeared to vary between zero at the front of the residence to approximately 6 feet (1.8 m) below the foundations under the rear portion of the building. There was a soft fill zone at the rear of the residences.. The rear of both residences was expected to continue to settle and, in effect, slide down the ravine causing differential movement from the front.

Due to both vertical and horizontal movement it was decided that vertical piers and horizontal anchors were needed for stabilization. Forty SS-150 Helical Piers[®] consisting of two helix lead sections were installed to prevent further vertical settlement. Installation depth varied from 11 to 25 feet (3.3 m to 7.6 m).

Five SS-175 **Chance[®] Tie Back Anchors** consisting of a three helix configuration were installed and attached to the rear concrete foundation to prevent further horizontal movement. An additional five SS-175 **Chance[®] Helical Piers** were installed to accommodate the vertical component of the horizontal load plus the dead load. **Chance[®] Helical Piers** were the most economical and least disruptive option that existed.
