Money in the Bank

HEATanchors speedy response saves Bank of America from potential disaster.

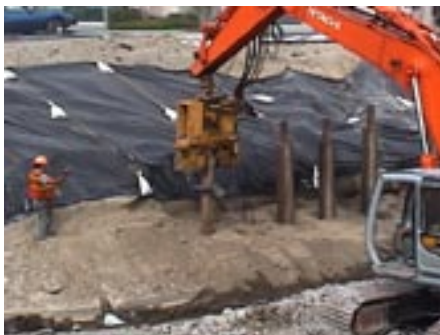
Driving HEATanchors helical soldier pile.

Quickly mobilizing installation equipment between the shopping center's main power feed and Bank of America's undermined foundation. We installed eighteen -10 5/8 inch O.D. Soldier pile, 15 feet deep with an 8-foot projection for a new soldier pile wall.

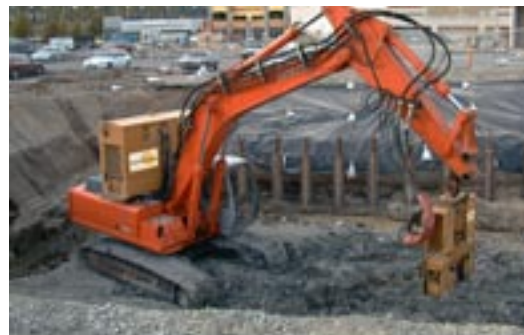
HEATanchors quickly mobilizes into action.
