Residential Foundation Repair

Childress Residence: Sylacuga, AL

Footing Foundation Repair Due to Sink Hole

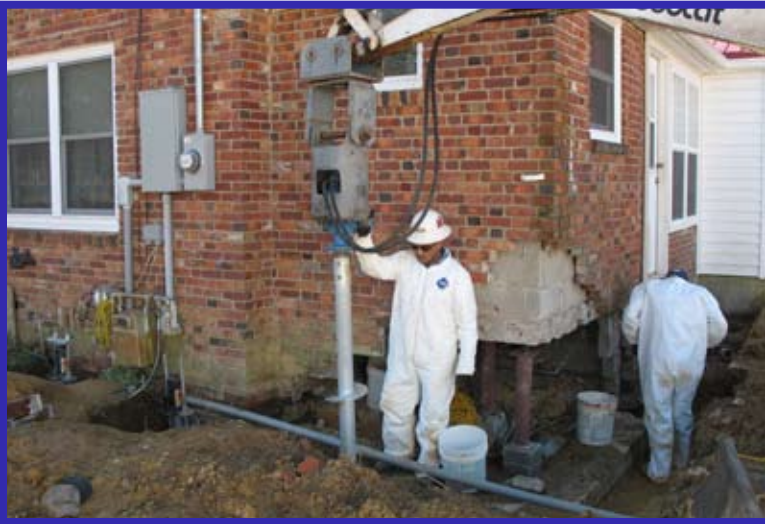
Helical Piles Driven and Terminated at 5,500 ft/lbs. of Torque

Based on the geotechnical report and construction conditions of residence, the recommendation was to install a combination of 3 1/2" 36000 series pipe helical piles with an 8" and 10" helical configuration, installed to 5500 foot-pounds of torque in conjunction with grout and pipe injection to stabilize the sinkhole area of the house at its rear corner.

AFSB installed seven Drive Rite Piering System™ 36000 series 3 1/2" helical piles with footing brackets (#98010G) and three 3 1/2" helical piles with new construction pile caps as recommended by engineering report to repair and replace the damaged foot-

ing, block foundation wall, and brick veneer. Installation of helical piles ranged from 11 to 40 ft. of depth.

Recommended torque was achieved and adequate pressure was applied to the lifting brackets to stabilize the footing and to reconstruct the failed footing area for reinstallation of foundation block and brick veneer.
