Case History, No. 4

The Problem

An eleven storey Condominium building in southern Ontario had been constructed in the early nineties on a dense clay till capping an artesian aquifer. Large open bottom sumps installed during the initial construction to control the groundwater, undermined four shear walls, two columns and the parking garage foundation walls on the south-west corner of the structure and disturbed the dense sand layer underneath the clay till.

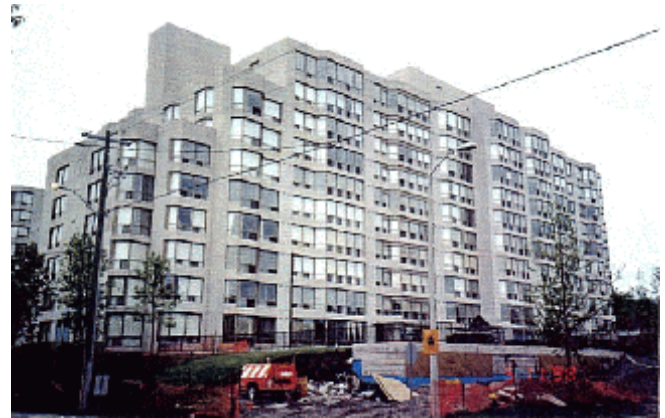
Considering the relatively limited access in the parking garage and the artesian aquifer, pile driving and caisson installation were not viable underpinning options.
